Nano102/112 Series Errata Sheet

Errata Sheet for 32-bit NuMicro™ Family

Abstract	This errata sheet describes the functional problem known at the release date of this document.
Apply to	Nano102/112 Series.

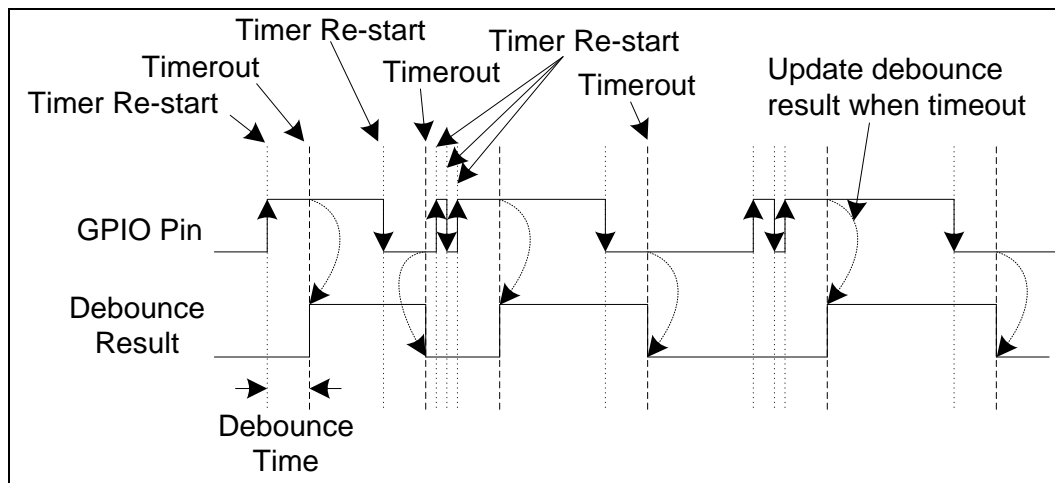
The GPIO de-bounce function cannot filter noise present at I/O pins completely.

The following figure shows the behavior of the software debounce flow. The timer is re-started whenever I/O transient. If there is no I/O transient within time-out period, the GPIO pin state at time-out will be assigned to a debounce result. If there is an I/O transient within time-out period, the timer will just be re-started without updating any debounce result.

Do not use the GPIO hardware debounce function. Use software debounce to filter unwanted input noise.

One software debounce method is to work with GPIO interrupt and a timer. The GPIO interrupt could be used to detect any I/O transient. The timer could be used to check if the I/O has transient within a period of time. By detect I/O transient with a period of time, user can skip all I/O transients shorter than specified period of time to achieve I/O debounce function.
