## M480 Series Errata Sheet

Errata Sheet for 32-bit NuMicro<sup>®</sup> Family

Abstract	This errata sheet describes the functional problem known at the release date of this document.
Apply to	M480 Series.

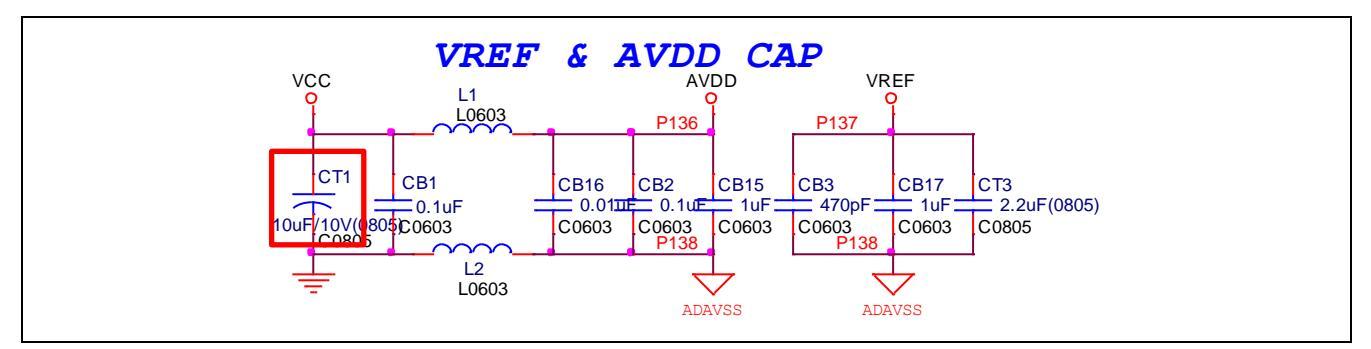
MCU wake-up from Deep Power-down mode (DPD) causes inrush current.

The M480 internal capacitor will be fully discharged when MCU enters DPD mode. When MCU is woken up from DPD mode, it draws current from power supply to recharge the internal capacitors and cause inrush current.

This issue can be fixed by a correct capacitor. Using correct capacitor can decrease inrush current impact. Here is the block diagram of  $V_{REF}$  & AV<sub>DD</sub> capacitors. Change the CT1 capacitor from 10uF to 22uF if the system needs smaller inrush current.
